Case Report

Catastrophic Failure of the Femoral Condylar Prosthesis in Total Knee Arthroplasty

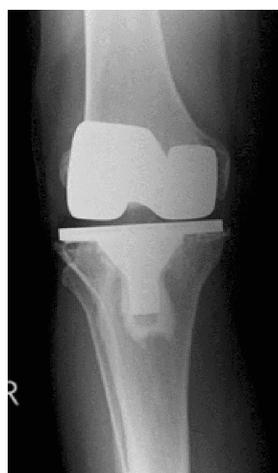
Figure 1: Plain AP radiograph 2013.

Radiographs of the right knee performed over the period 2012–2015 revealed marked polyethylene wear; see Figures 1, 2, and 3. Radiographs from the original hospital were reviewed. A knee series taken at the time of presentation to Accident and Emergency Department revealed significant polyethylene wear and a minimally displaced fractured medial femoral component; see Figures 4 and 5. Routine blood tests and inflammatory markers were normal.

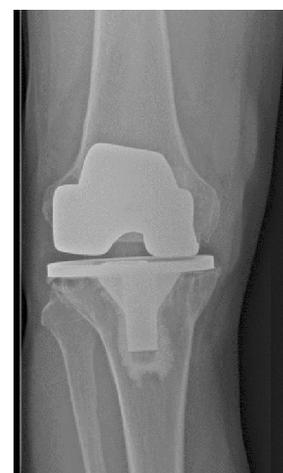
Figure 2: Plain AP radiograph 2014.

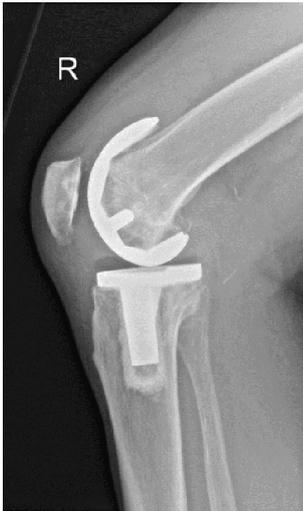
Figure 3: Plain lateral radiograph 2014.

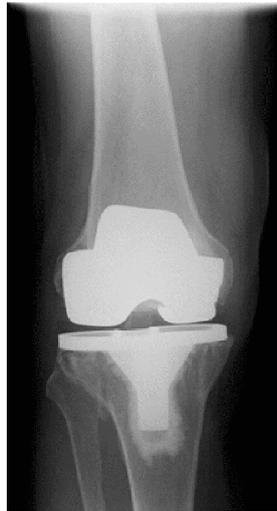
Figure 4: Plain AP radiograph 2015.

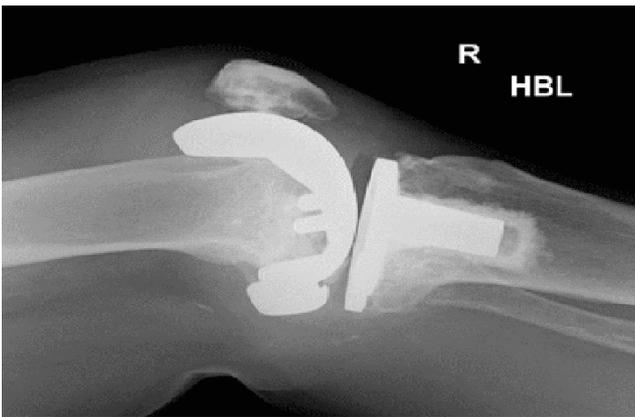
Figure 5: Plain lateral radiograph 2015.

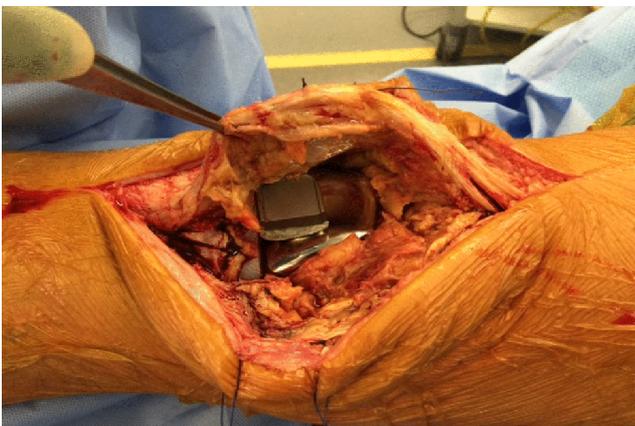
Figure 6: Intraoperative photo showing knee in extension fractured medial femoral condyle sat in the patella-femoral joint.

The patient was consented for single stage revision knee replacement. The previous midline incision was used. On completion of the arthrotomy, the fractured femoral component was located in the patellofemoral joint; see Figure 6. Synovial specimens were sent for histology and culture which confirmed polyethylene wear and metallosis. No infection was present.

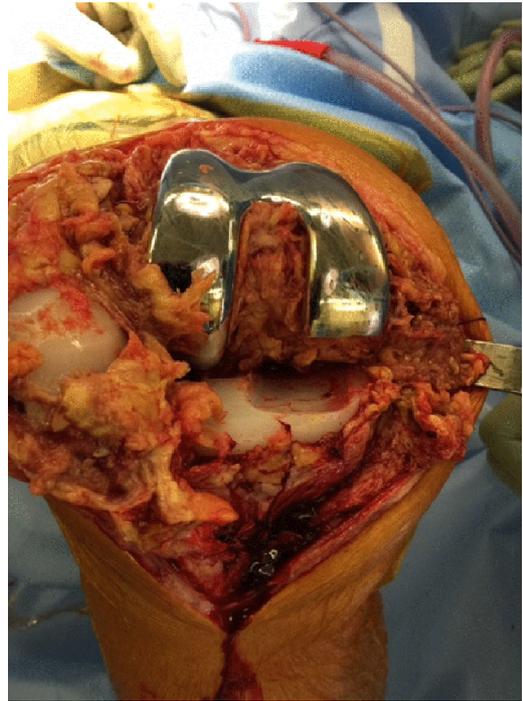
Figure 7: Intraoperative photo showing knee in flexion with the fractured medial femoral condyle visible.

The femoral component was loose and the medial condyle fractured without attached cement or bone involvement; see Figures 7, 8, and 9. Fibrous tissue was found at the prosthesis bone interface globally around the

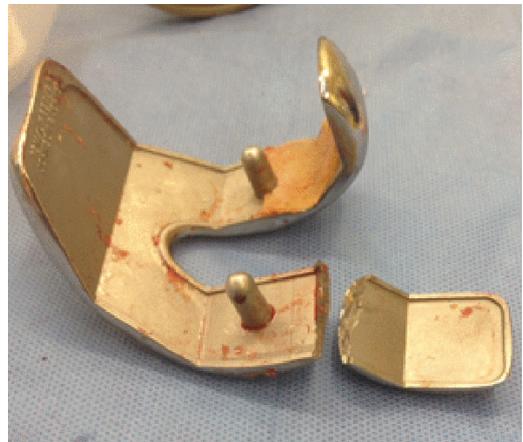
Figure 8: Explanted femoral device.

femoral component; the cement mantle on the femoral side was found to be grossly incomplete. The tibial component was well fixed, with the tibial tray demonstrating marked polyethylene wear; see Figure 10. A single-stage stemmed revision was undertaken; see Figures 11 and 12.

It was felt at the time of revision that the cause for failure in this instance was poor cement technique, resulting in the ingress of fibrous tissue between bone and prosthesis. The subsequently loose prosthesis fatigued and progressively mechanically failed over a three-year period. The component catastrophically failed on one episode of extreme exertion. This case report highlights the need of proper cement techniques, and the suspicion of failing components with appropriate investigations in the light of radiographical changes to the underlying polyethylene. We recommend timely revision of total knee arthroplasty, where component failure is suspected, as this may prevent further damage.

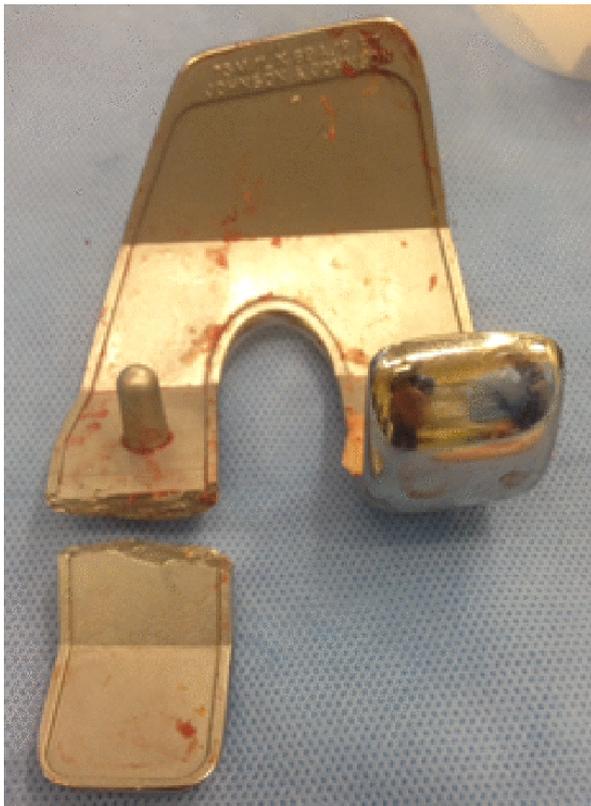
Figure 9: Explanted femoral device.

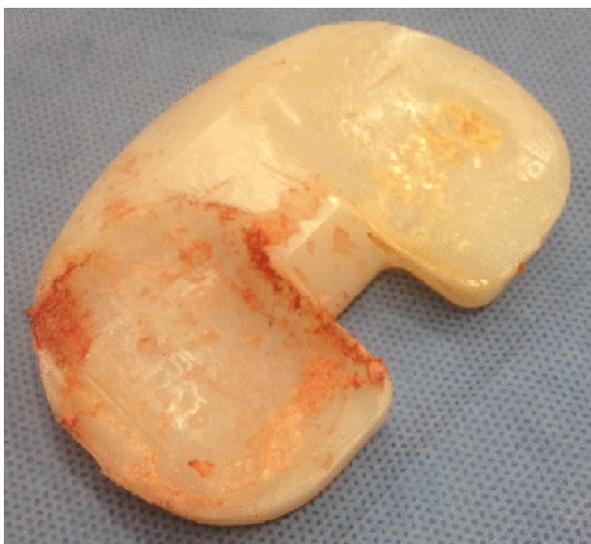
Figure 10: Massive wear of the tibial tray.
